MERRIMACK RIVER BASIN
SALEM, NEW HAMPSHIRE

TAYLOR DAM
NH 00026

PHASE I INSPECTION REPORT
NATIONAL DAM INSPECTION PROGRAM

NOVEMBER 1978

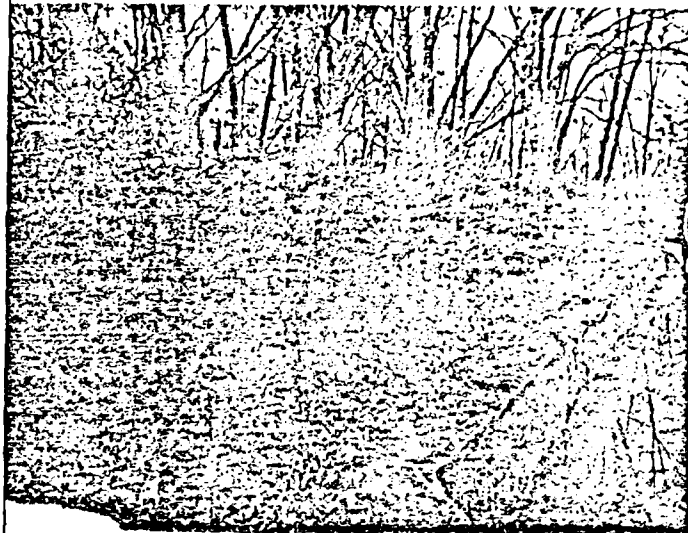
Showing erosion of concrete.

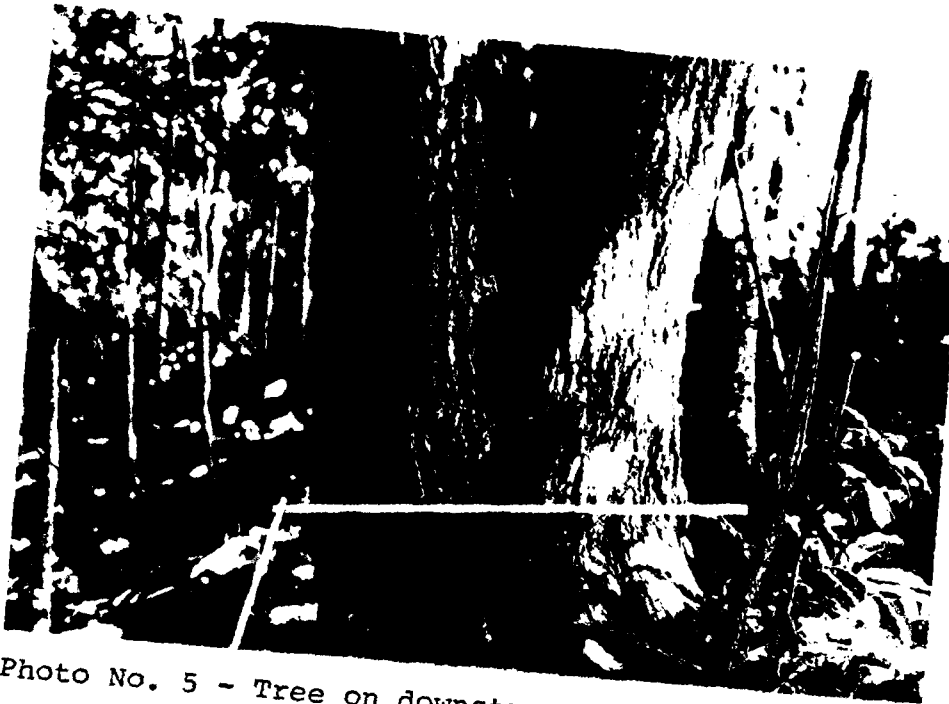
Photo No. 5 - Tree on downstream slope 12 feet from crest of dam. Horizontal rule equals 3 feet.

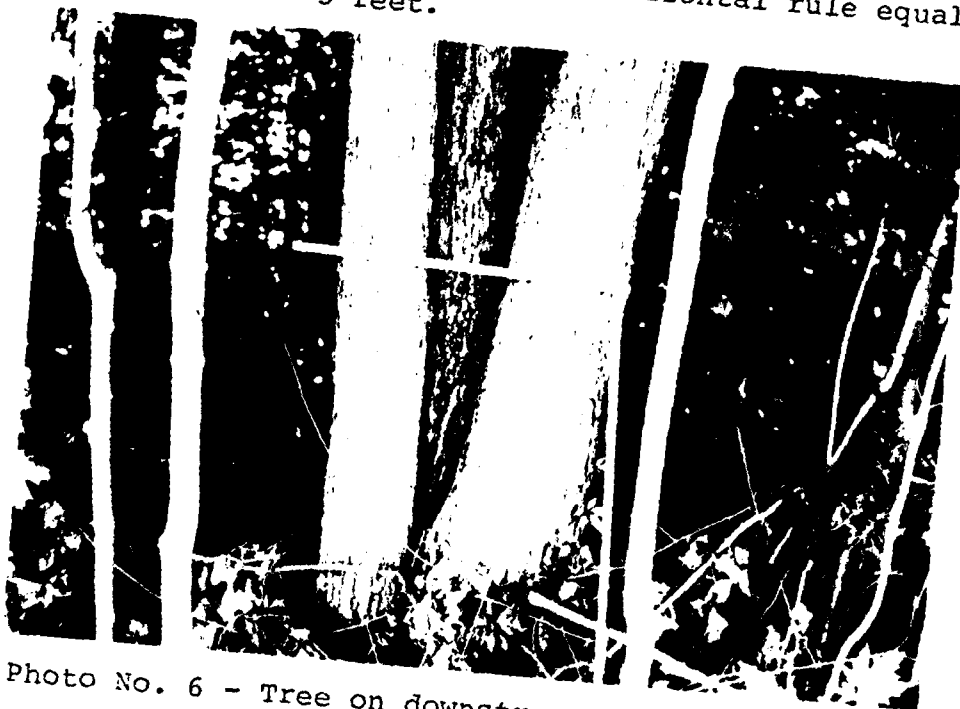
Photo No. 6 - Tree on downstream slope 8 feet from crest of dam. Horizontal rule equals 2 feet.
